AGARD CONFERENCE PROCEEDINGS 565

## Corrosion Detection and Management of Advanced Airframe Materials

*Papers presented at the 79th Meeting of the AGARD Structures and Materials Panel, held in  
Seville, Spain, 5-6 October 1994.*

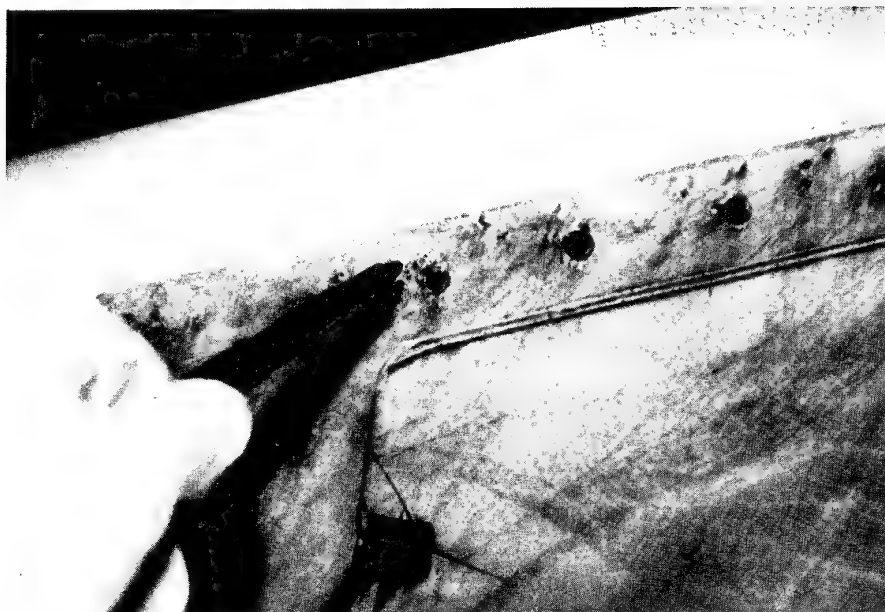
**MR TIP CAP CORROSION ADJACENT TO ATTACHMENT SCREW**
